# **ACTIVE CLEANING TECHNIQUE FOR REMOVING CONTAMINATION FROM OPTICAL SURFACES IN SPACE**

**FINAL REPORT  
D180-17610-1  
AUGUST 1973**

**CONTRACT NAS8-26385**

**BY  
Boeing Aerospace Company  
Research & Engineering Division  
Seattle, Washington 98124  
A Division of the Boeing Company**

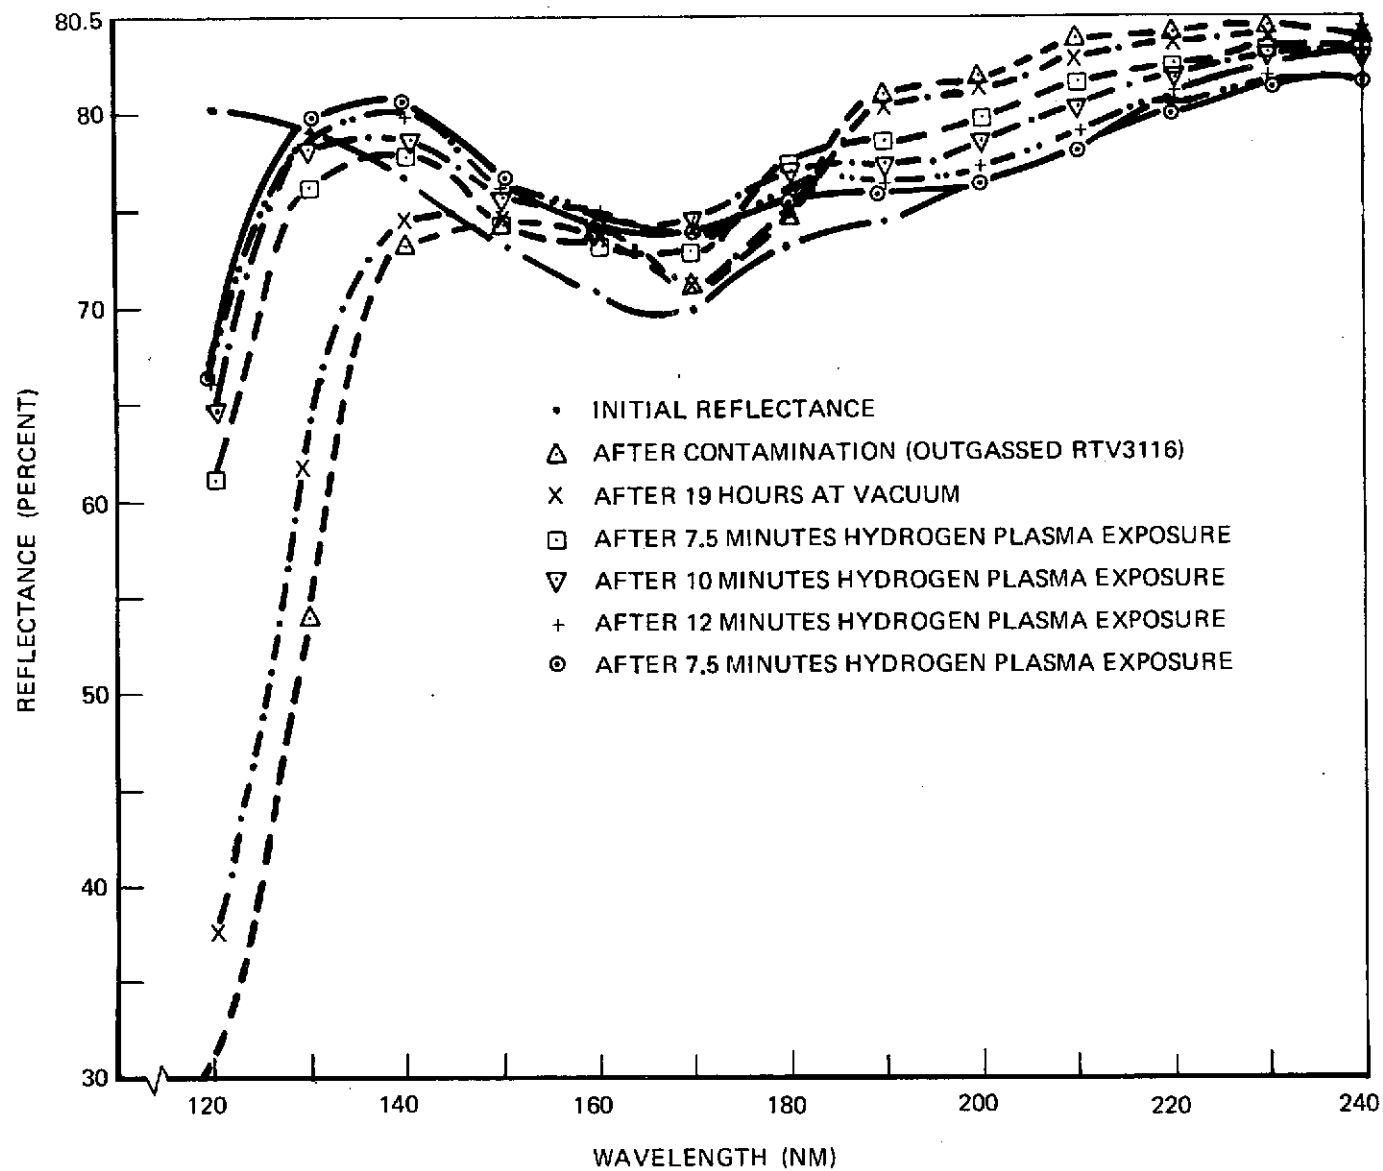
A second  $\text{MgF}_2/\text{Al}$  mirror (MgF 114) was exposed to the outgas products of RTV3116 for 30 minutes. The QCM response indicated a contaminant film deposition of about  $1.5 \times 10^{-6} \text{ gm/cm}^2$ . The effects of the contaminant film on the UV reflectance are similar to those observed for sample MgF 113 (see Figure 24). The data in Figure 24 also indicate that some of the contaminant film evaporated, as before, during a 19 hour exposure to vacuum. This sample was subjected to a series of hydrogen plasma exposures of 7.5, 10, 12 and 7.5 minutes. As with the helium plasma exposures of MgF 113, the hydrogen plasma exposures increased the reflectance of MgF 114 at the shorter wavelengths and decreased it at the longer wavelengths. However, the hydrogen plasma produced more restoration at the shorter wavelengths and less degradation at the longer wavelengths, than the helium plasma. Subsequent to this series of plasma exposures the sample was left under vacuum for 18 hours and then subjected to three additional plasma exposures (12 minutes using hydrogen, 9 minutes using oxygen and 7.5 minutes using helium). Figure 25 shows the reflectance data for these cases. The hydrogen plasma exposure resulted in a slight improvement at the shorter wavelengths and slight degradation at the longer wavelengths. The oxygen plasma exposure resulted in slight further degradation. The helium plasma exposure produced a significant further degradation of the reflectance.

Figure 24: REFLECTANCE DATA FOR Mg F<sub>2</sub>/Al MIRROR Mg F114

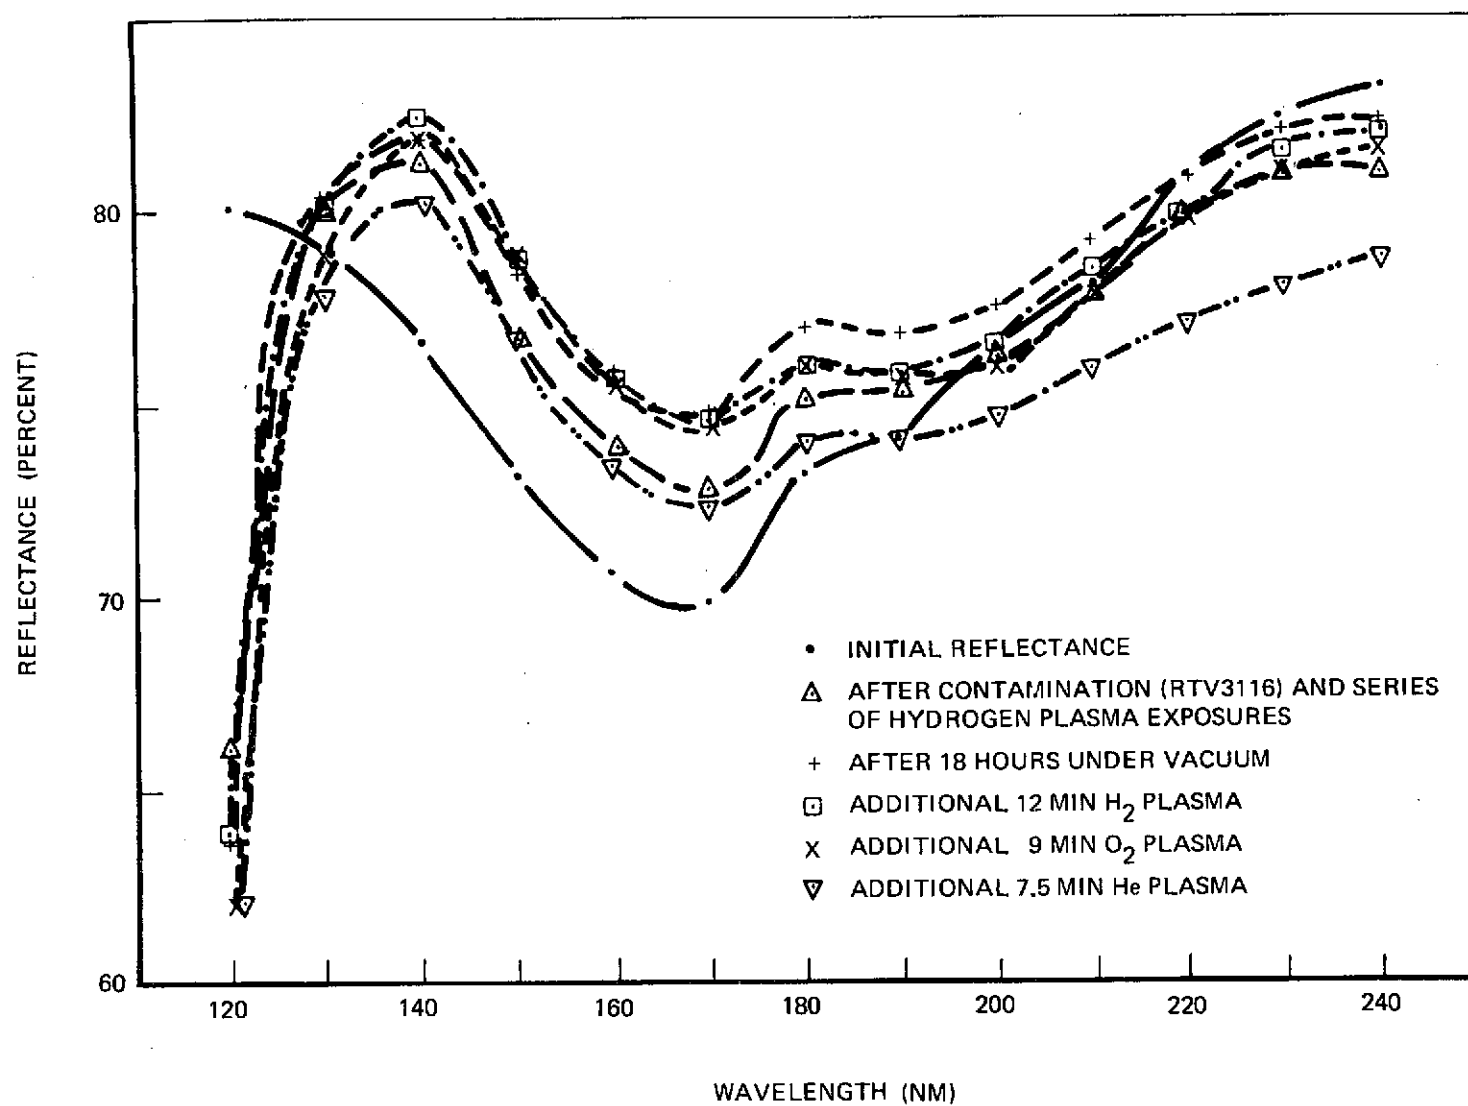
Figure 25: REFLECTANCE DATA FOR Mg F<sub>2</sub>/Al MIRROR Mg F114

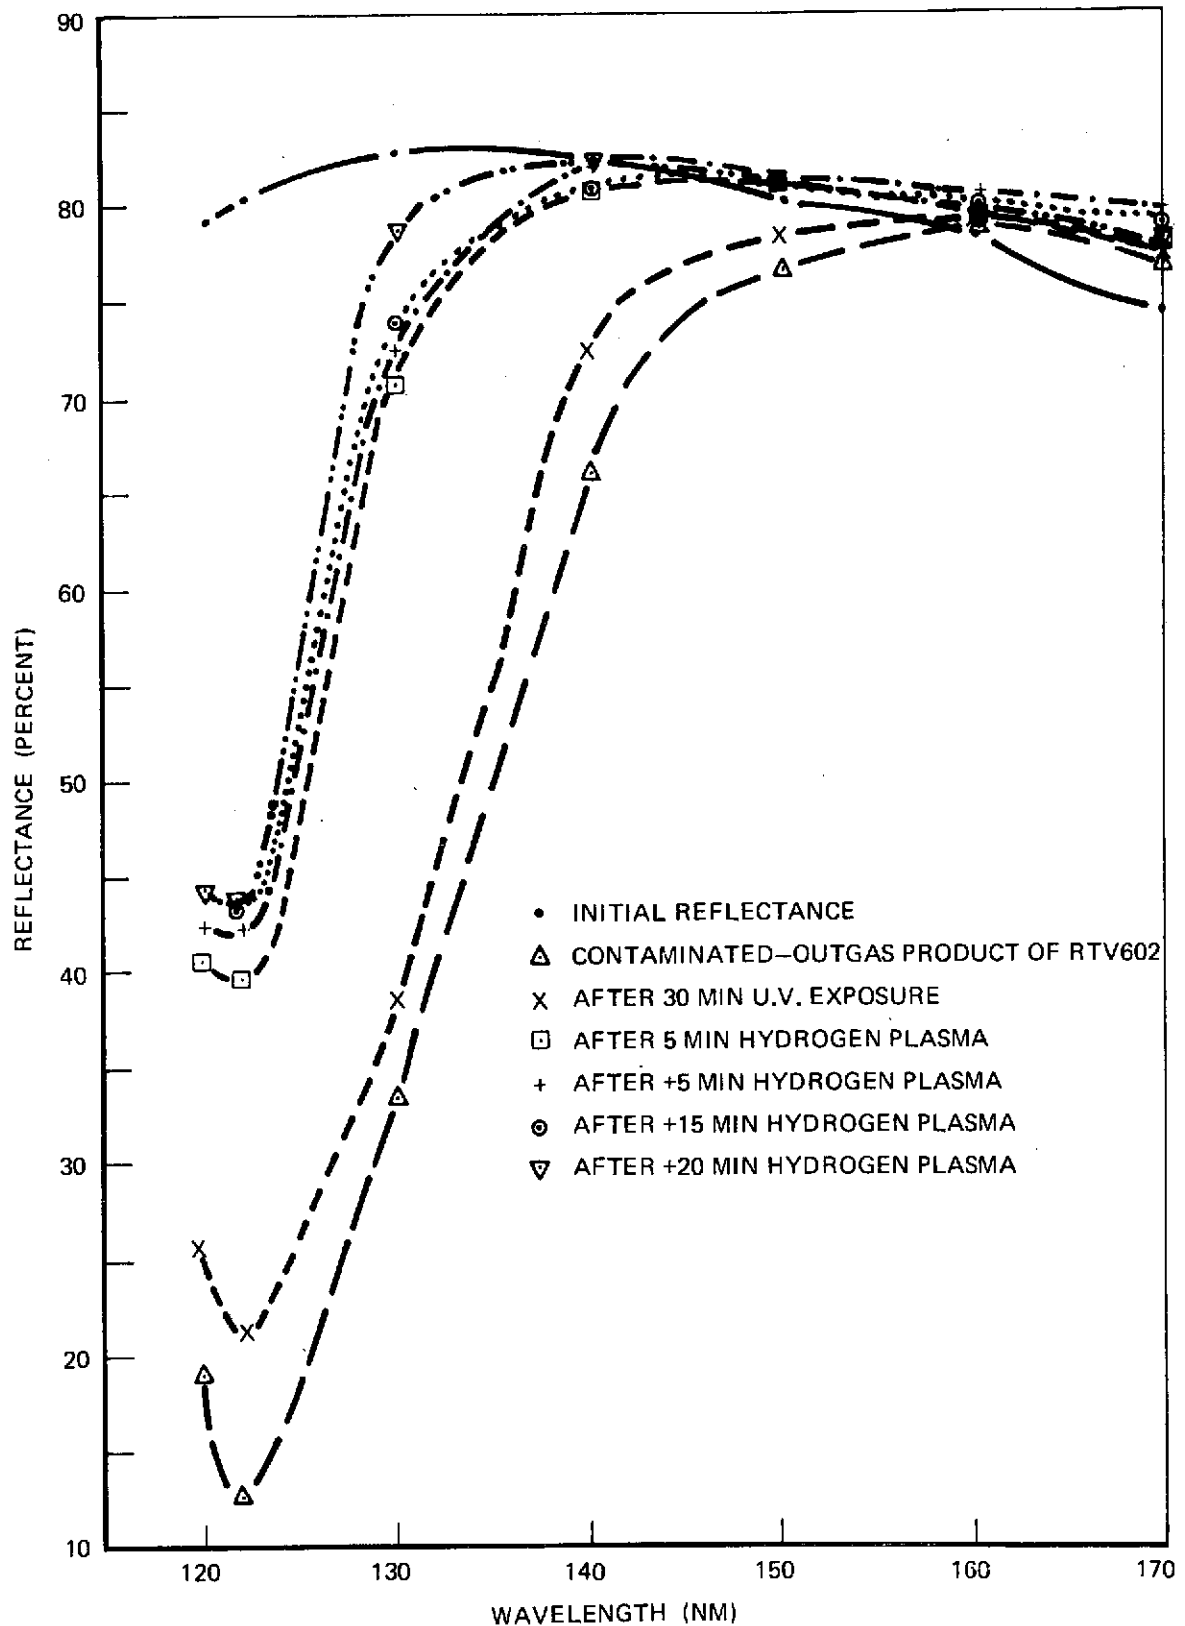
Figure 26: REFLECTANCE DATA FOR Mg F<sub>2</sub>/Al MIRROR Mg F116

These initial experiments showed that the UV reflectance of  $\text{MgF}_2/\text{Al}$  coated mirrors, contaminated with the outgas products from RTV3116, could be partially restored using helium and hydrogen plasmas. Further experiments were conducted using the outgas products of RTV602 to contaminate  $\text{MgF}_2/\text{Al}$  coated mirrors. The silicone compounds in RTV602 are similar to those in S-13 white paint (a space-craft coating). These experiments utilized a sapphire window in the in-situ monochromator to extend the reflectance measurements to 300 nm. Two mirrors were used in these tests. The first mirror MgF 116 was exposed to the RTV602 outgas products for 27 minutes. The QCM response indicated a contaminant film deposition of about  $2.2 \times 10^{-6} \text{ gm/cm}^2$ . During this exposure a gold coated glass slide was also contaminated. This slide was placed in the chamber contamination inlet port so that a thick contaminant film would result. Subsequent infrared analysis of this film revealed the presence of dimethylsiloxane. Subsequent to contamination, sample MgF 116 was exposed to UV radiation for 30 minutes. This exposure produced some restoration of the reflectance. (The reflectance data for MgF 116 are shown in Figures 26 and 27 for the 120-170 nm and 160-300 nm wavelength regions, respectively). The sample was then subjected to a series of hydrogen plasma exposures. Figure 26 shows that these exposures produced a significant restoration of the reflectance at shorter wavelengths, and Figure 27 shows a progressive degradation at the longer wavelengths. Two additional hydrogen plasma exposures totaling 52.5 minutes produced little change in the shorter wavelengths and slight further degradation at the longer wavelengths. (These data are not shown in Figures 26 and 27).

whereas, that for MgF 116 showed only the 122 nm minimum. This difference might be explained by the fact that, after contamination, MgF 116 was left under vacuum and then let up to air prior to the reflectance measurement; or that MgF 117 had a somewhat thicker contaminant film. Figure 28 shows that the minimums at 127 and 132 nm were removed by oxygen plasma exposure, however, the restoration at 122 nm was much less than that obtained for MgF 116 using hydrogen plasma exposure. The data shown in Figure 28 also show that the reflectance at the shorter wavelengths is initially increased and then progressively degrades with continued exposure to an oxygen plasma. Figure 29 shows somewhat the opposite effect at the longer wavelengths.

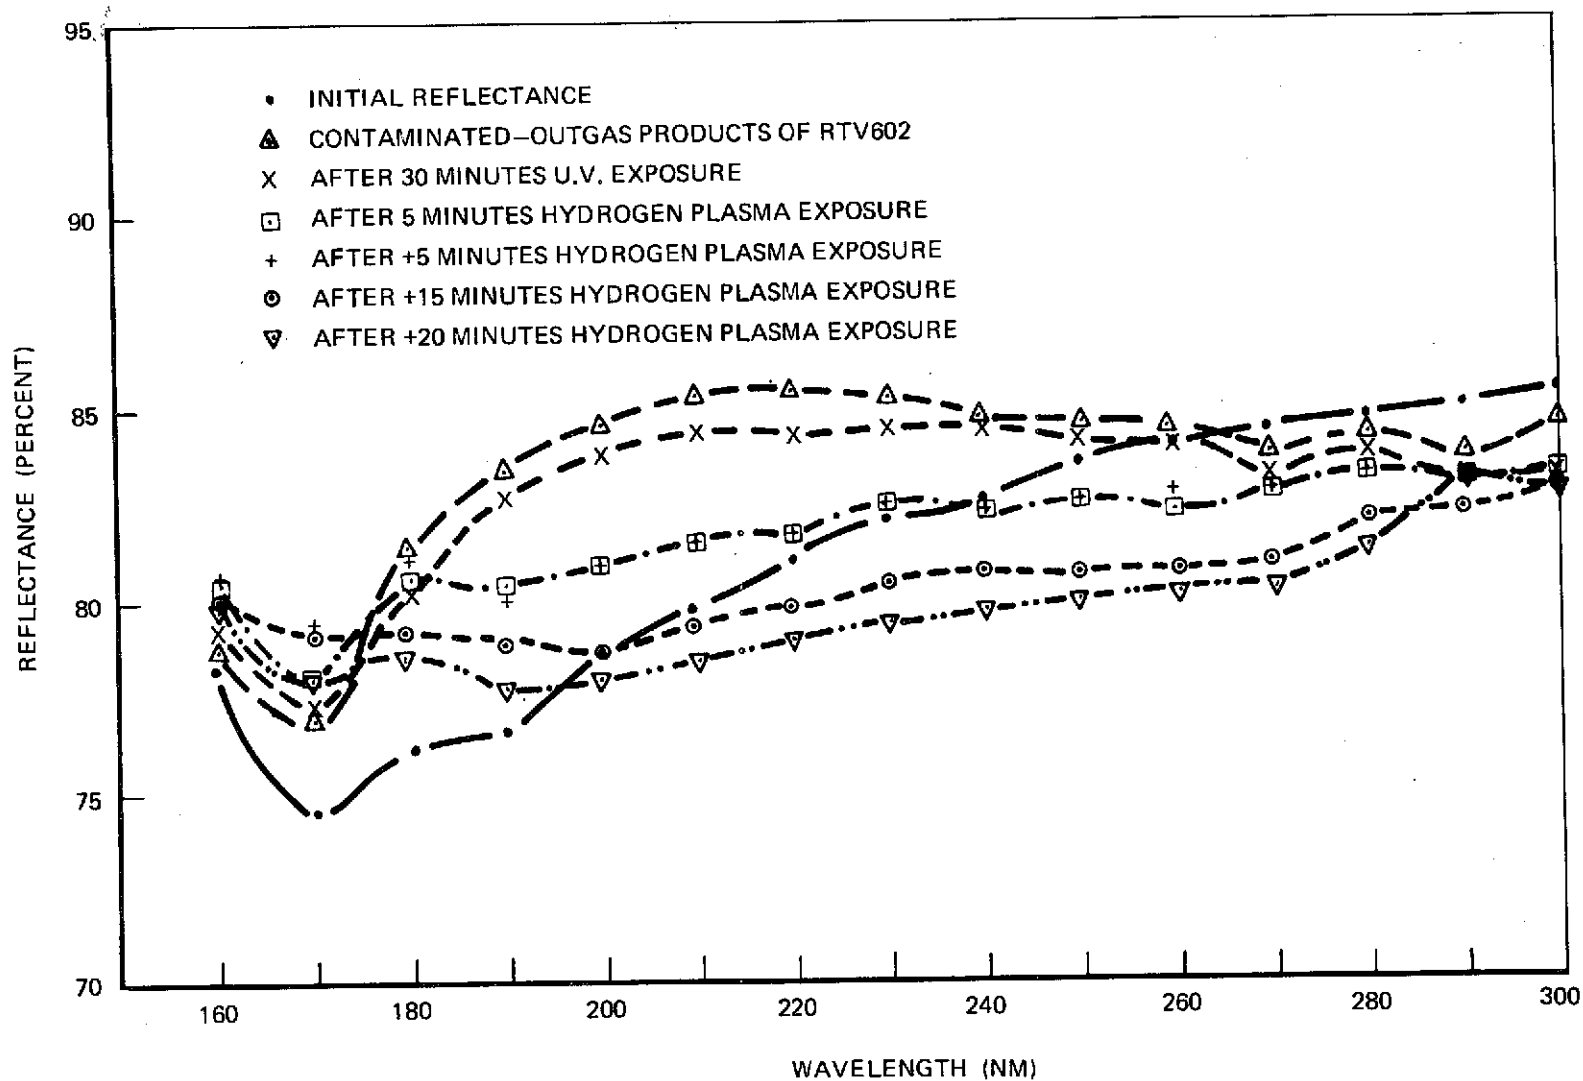
Figure 27: REFLECTANCE DATA FOR Mg F<sub>2</sub>/Al MIRROR Mg F116

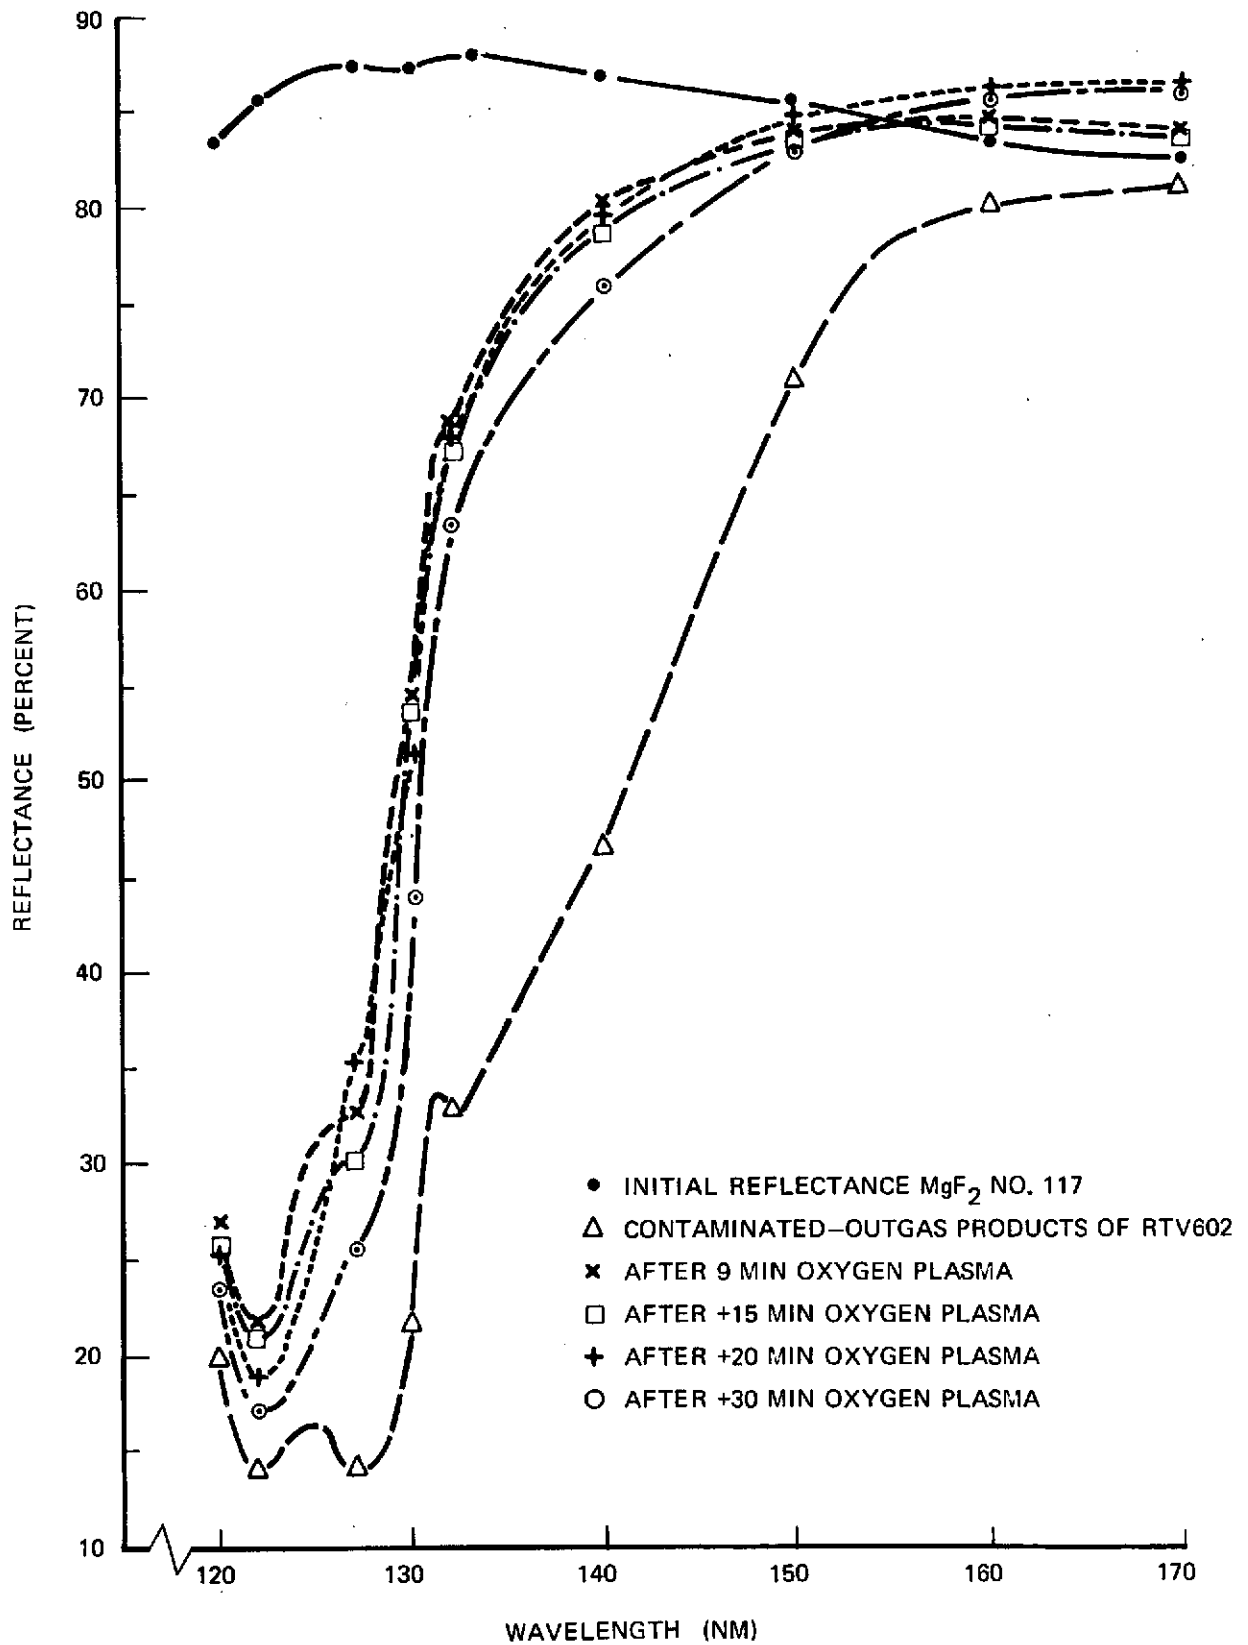
The second mirror MgF 117 was first exposed to the outgas products of RTV602 for 75 minutes with a resultant indicated film deposition of only about  $0.8 \times 10^{-6} \text{ gm/cm}^2$ . A subsequent reflectance measurement revealed negligible contamination. During this initial contamination attempt the chamber pressure was about  $10^{-3}$  torr. At first this pressure was attributed to outgassing effects, however, a system leak was discovered later. After sealing the leak, the sample contamination procedure was repeated. A 30 minute exposure then resulted in a total indicated film deposition of about  $3 \times 10^{-6} \text{ gm/cm}^2$ . The sample was then exposed to a series of oxygen plasma exposures. Figures 28 and 29 show the reflectance data for mirror MgF 117 in the 120-170 nm and 160-300 nm wavelength regions, respectively. The degraded reflectance, prior to plasma exposure, shows minimums at about 122, 127 and 132 nm,

Figure 28: REFLECTANCE DATA FOR Mg F<sub>2</sub>/Al MIRROR Mg F117

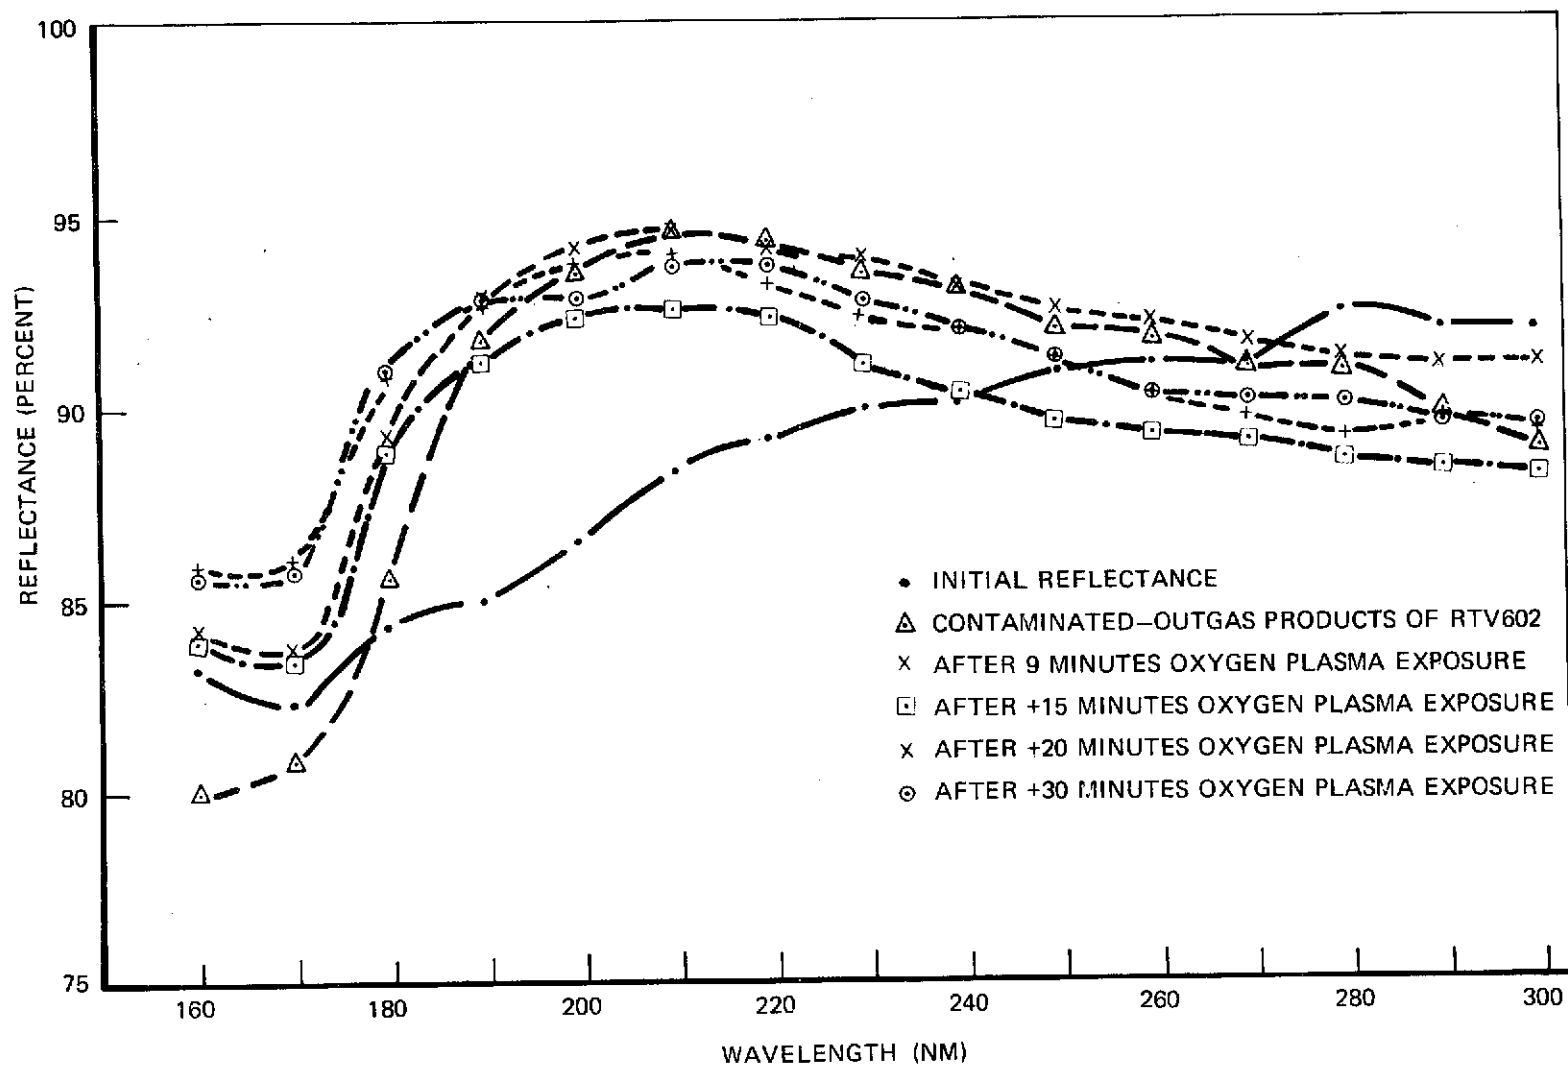
Figure 29: REFLECTANCE DATA FOR Mg F<sub>2</sub>/Al MIRROR Mg F117)

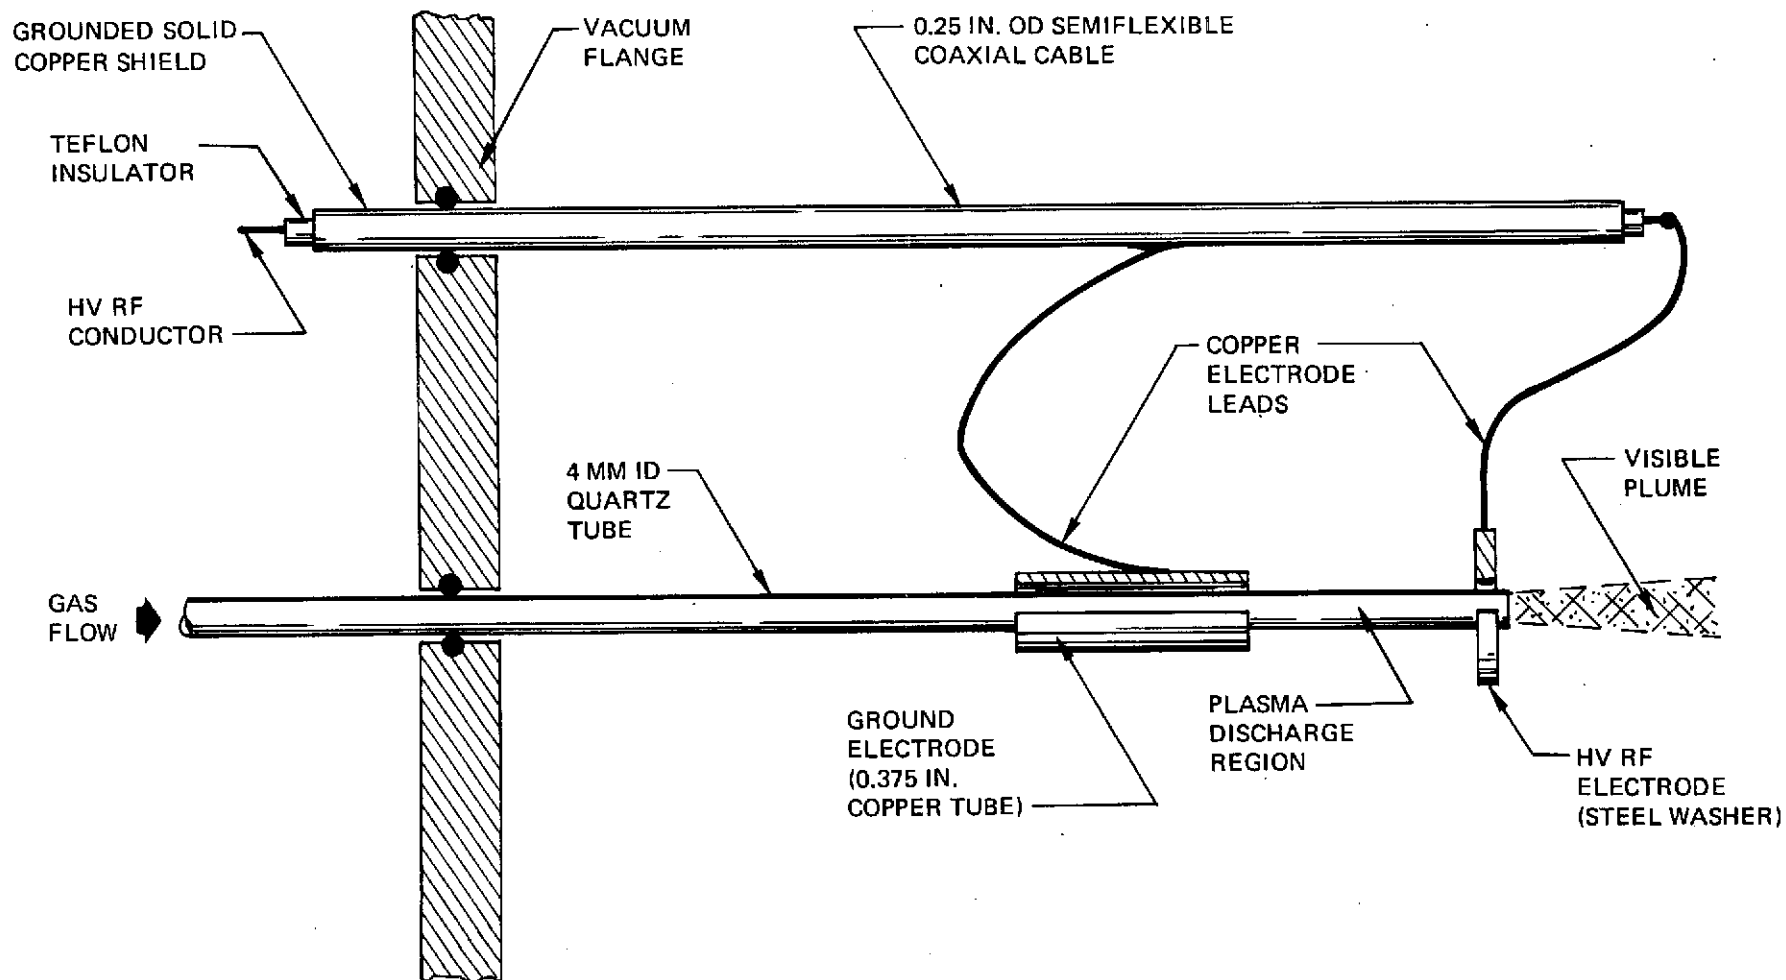
The development of a plasma tube that would operate at low chamber pressures ( $10^{-5}$  to  $10^{-4}$  torr) is covered under companion Contract NAS8-28270. The initial plasma tube developed under that contract (Reference 7) produced atomic oxygen (based on silver oxidation) at low chamber pressures, however, it did not produce plasma cleaning effects. Continuation of the plasma tube development effort revealed that a visible plume (i.e., a localized, glowing, conical shaped region extending beyond the plasma tube into the vacuum chamber) could be produced at low chamber pressures if the plasma discharge extended to the downstream end of the plasma tube. It was also found that plasma cleaning occurred within the region of the visible plume. Preliminary experiments were conducted, using a prototype plasma tube, to determine whether contamination occurs on surfaces adjacent to those being cleaned, and the cleaning rate distribution. Figure 30 shows the prototype plasma tube configuration used in these experiments. A 4 mm ID quartz tube with axial electrodes was used as the plasma tube. The r.f. power was brought into the chamber through a separate passthrough and the electrodes leads were connected using soft solder.

Figure 30: PROTOTYPE PLASMA TUBE CONFIGURATION

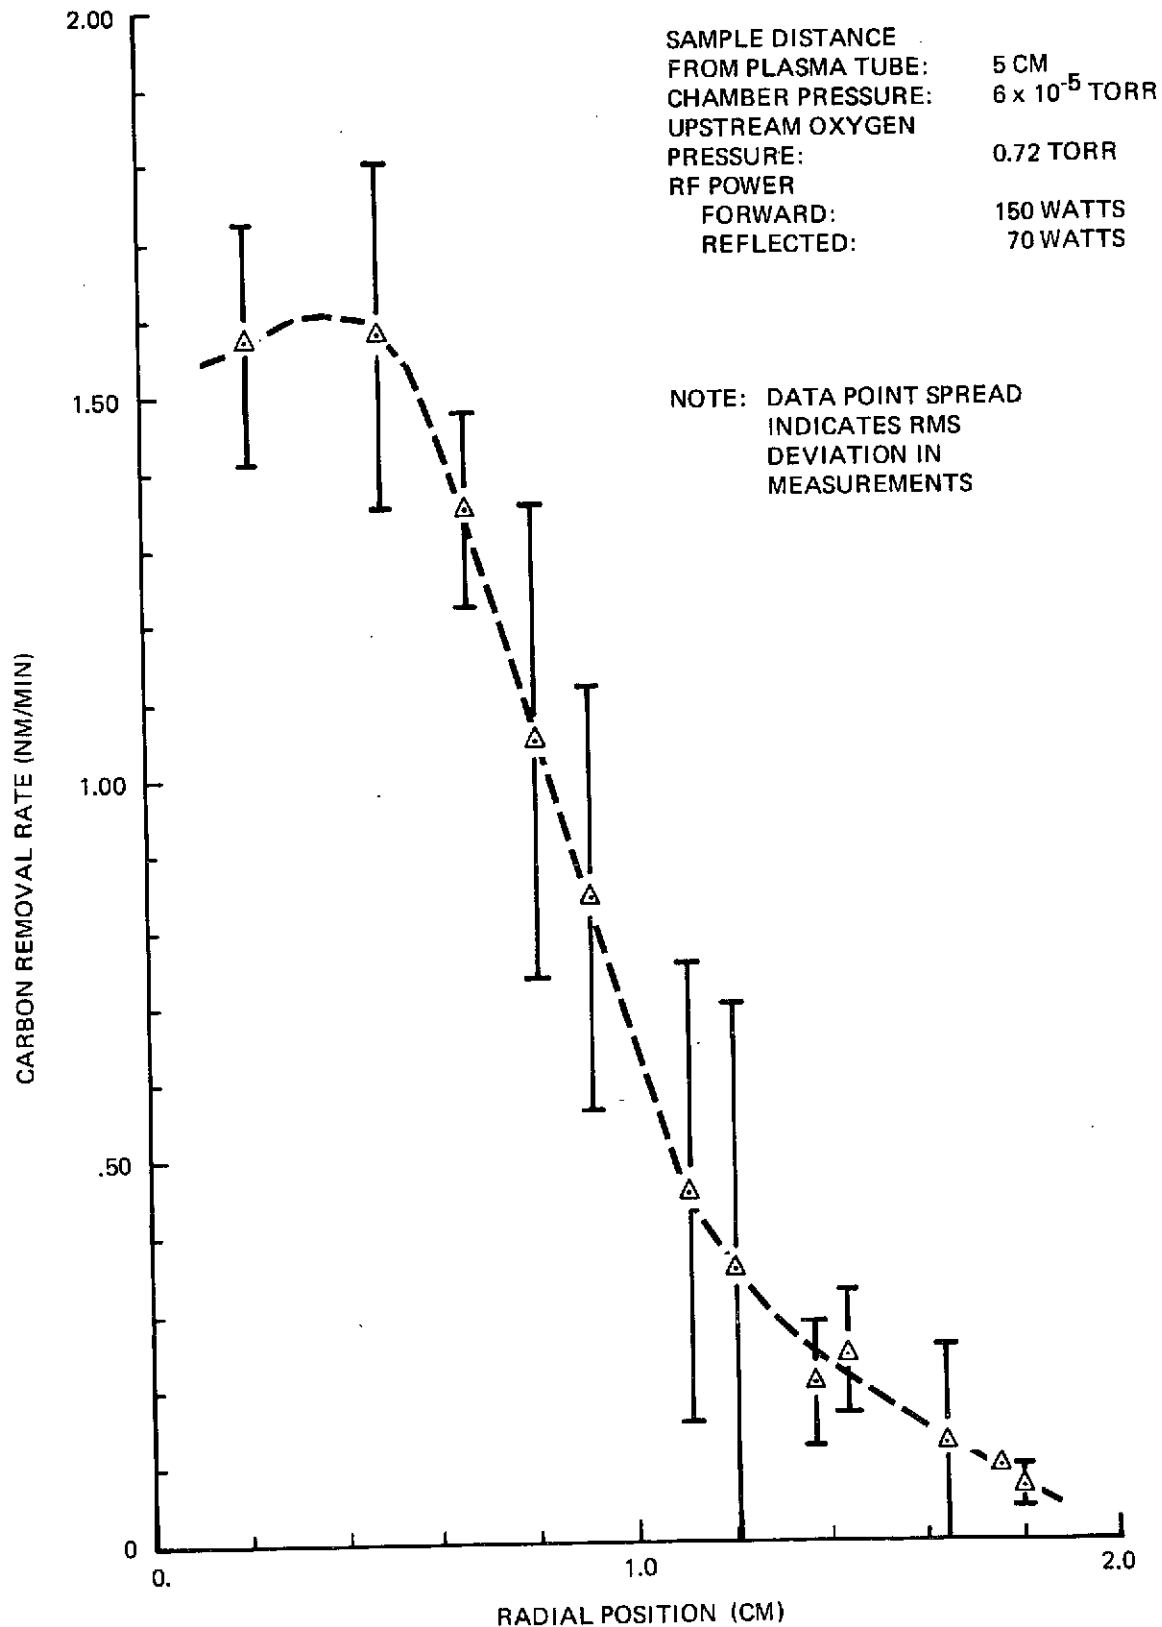
however, no pattern of cleaning was apparent. A new slide was then prepared with 260 nm of vacuum deposited carbon and aluminum strips (60 nm thick) vacuum deposited onto the carbon. This slide was exposed for 2.5 hours at about 11 cm from the plasma tube under the following operating conditions; chamber pressure  $4 \times 10^{-5}$  torr, upstream oxygen pressure 0.65 torr, and r.f. power at 100 watts forward and 60 watts reflected. After vacuum depositing aluminum cross-strips on the slide, interferometry measurements indicated carbon removal of up to about 16 nm but no definite cleaning pattern was apparent. This slide was then positioned closer to the plasma tube (about 5 cm distance) and exposed for 30 minutes under the following conditions; chamber pressure  $6 \times 10^{-5}$  torr, upstream oxygen pressure 0.72 torr, and r.f. power at 150 watts forward and 70 watts reflected. Post-test interferometry measurements indicated carbon removal of up to 65 nm with a definite pattern of removal. An area of the slide, about 2 cm diameter, showed significantly greater carbon removal than that for the remaining area. Figure 31 shows the cleaning rate distribution obtained by averaging the interferometry measurements at equal distances from the apparent center of the cleaned area. The rms deviations in the measurements are also shown in Figure 31. These deviations give an indication of the accuracy of the cleaning rate distribution determination.

Figure 31: CLEANING RATE DISTRIBUTION

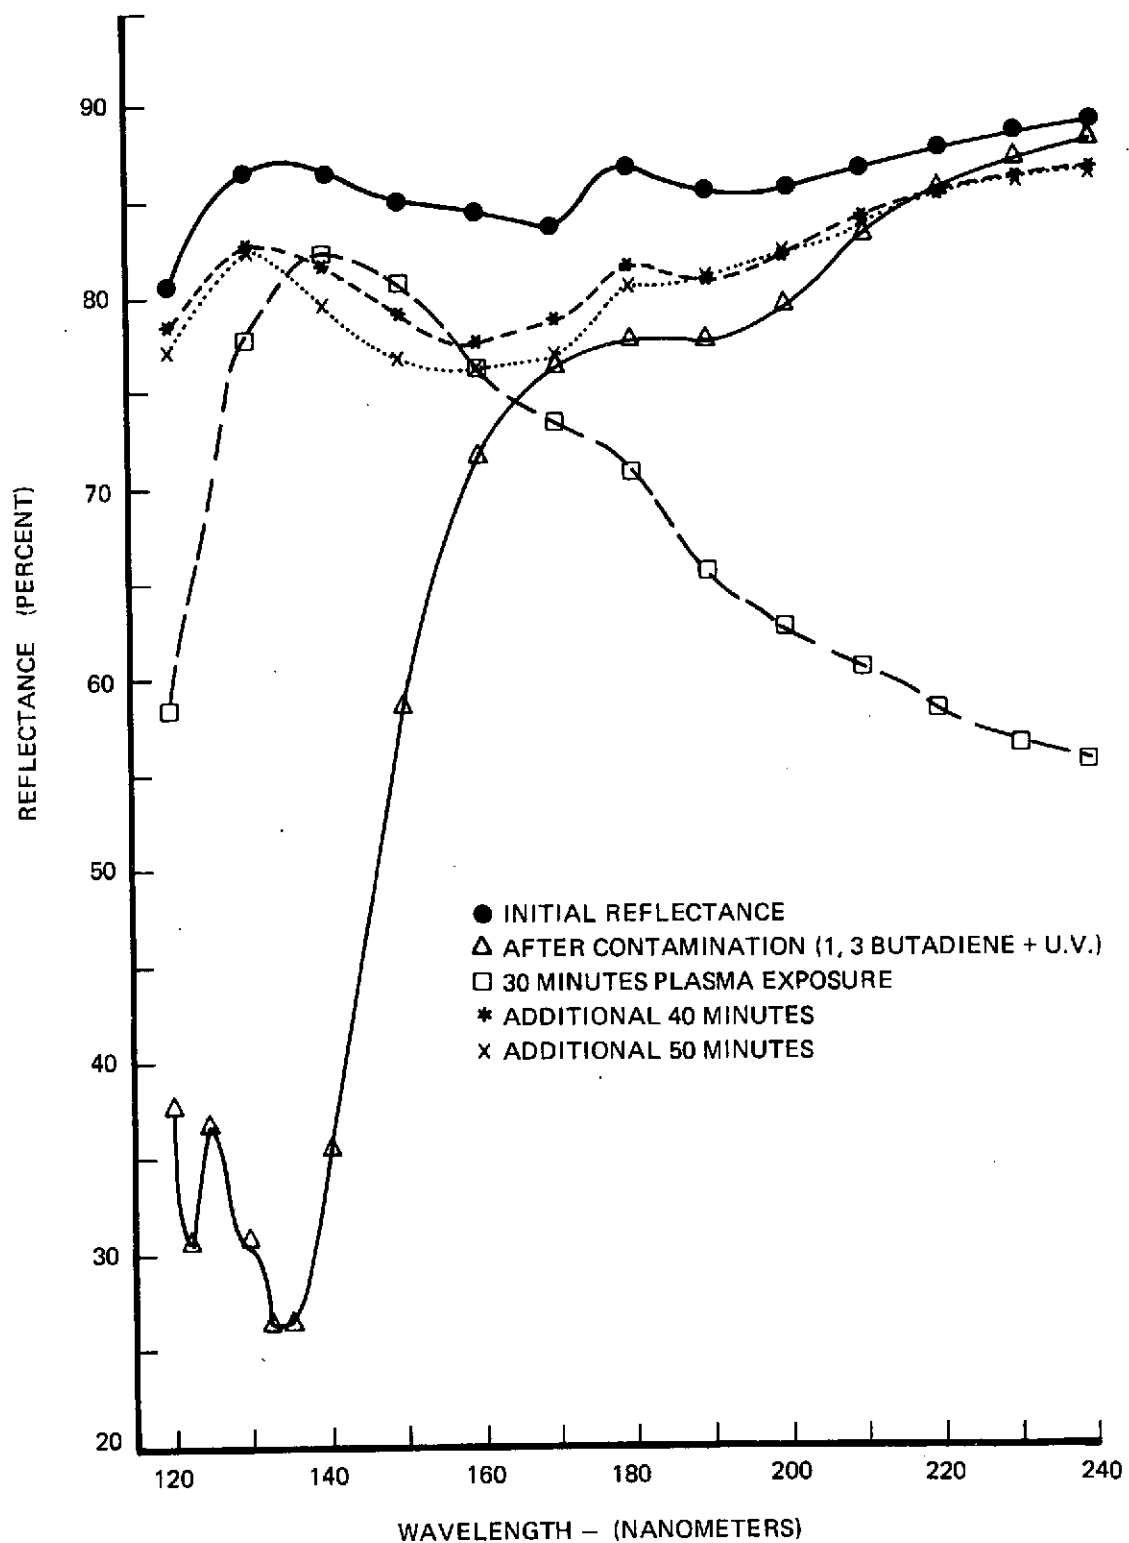
Mirror MgF 57 was cleaned in a series of plasma exposures of 30, 40 and 50 minutes duration. The operating conditions for these exposures were; chamber pressure  $4 \times 10^{-5}$  torr, upstream oxygen pressure 0.65 torr, and r.f. power at 130 watts forward and 80 watts reflected. Figure 32 shows the reflectance data for MgF 57. The first two exposures increased the reflectance and the final exposure produced a slight decrease in reflectance. After completing the plasma exposures, the system was let up to air and the reflectance of mirror MgF 118 was remeasured. Figure 33 shows the reflectance data for MgF 118. These data indicate that MgF 118 was contaminated during the plasma cleaning of the adjacent mirror. However, there exists uncertainty as to whether or not the contamination of MgF 118 was caused by the contaminant cleaning of the adjacent surface. In the experimental set-up mirror MgF 118 was in close proximity to the end of the semi-flexible coaxial cable (see Figure 30). When the plasma tube was in operation considerable heat was generated in the r.f. leads due to the impedance mismatch in the prototype system. This heating may have caused outgassing of the exposed teflon insulation and/or the soft solder connections used for the electrode leads. This outgassing would also explain the failure of the plasma to completely restore the reflectance of mirror MgF 57.

Figure 32: REFLECTANCE DATA FOR  $MgF_2/Al$  MIRROR Mg F57

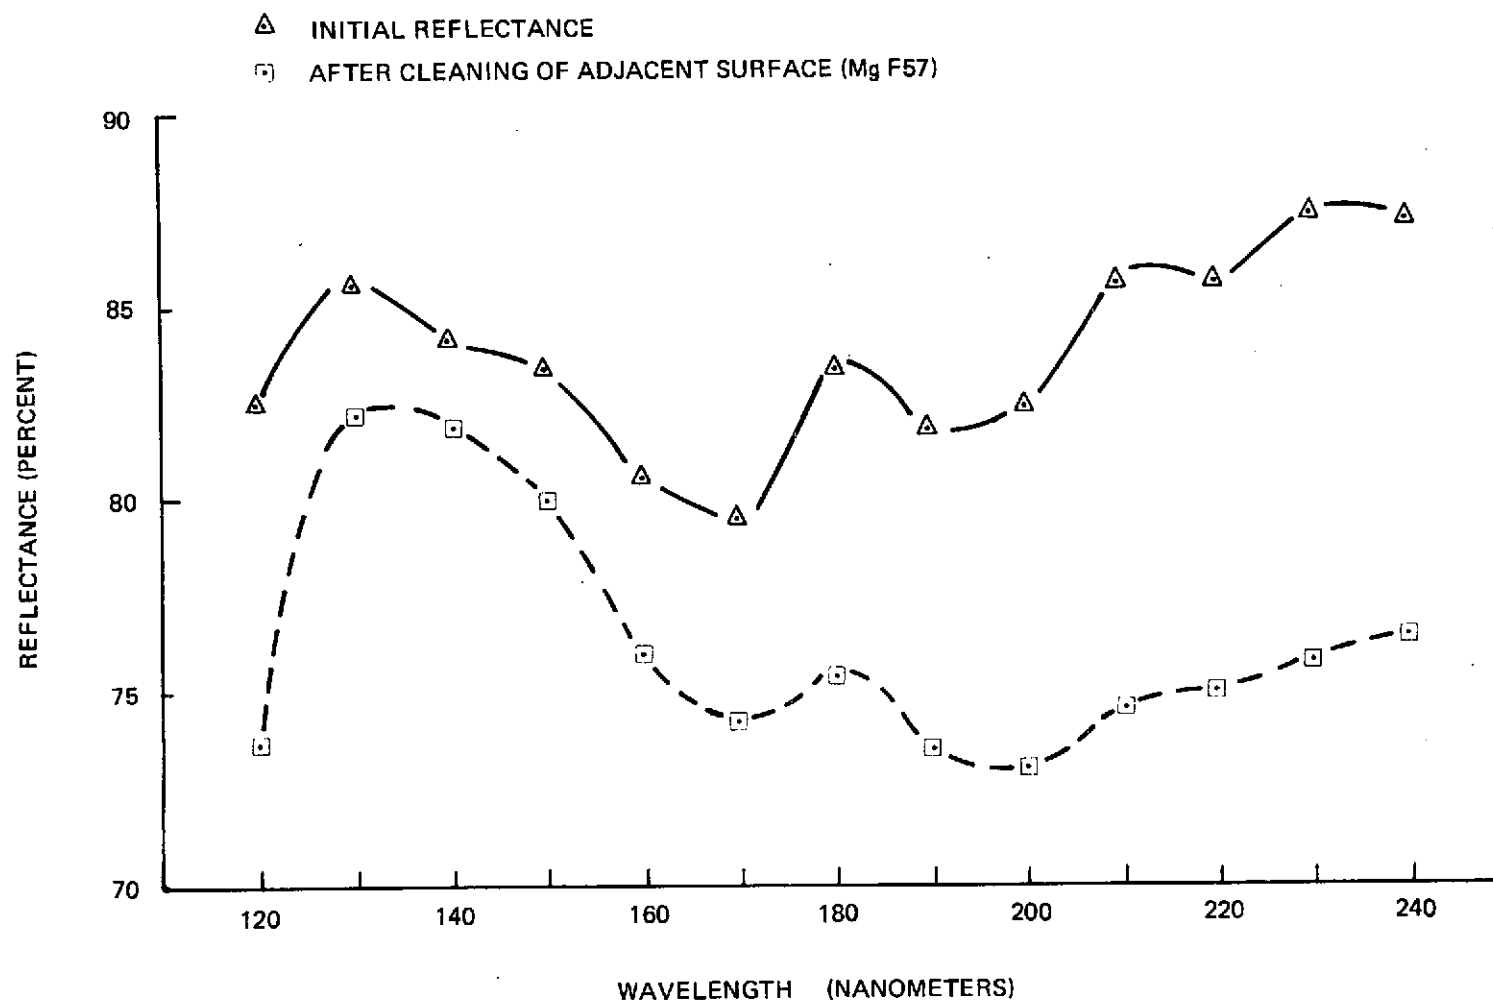
Figure 33: REFLECTANCE DATA FOR Mg F<sub>2</sub>/Al MIRROR Mg F118
